**DEVELOPMENTAL HALT REPORT**  
**R-0000274**

**Product Tested:** 600W power supply

**Service Proposal #:** S-0000274

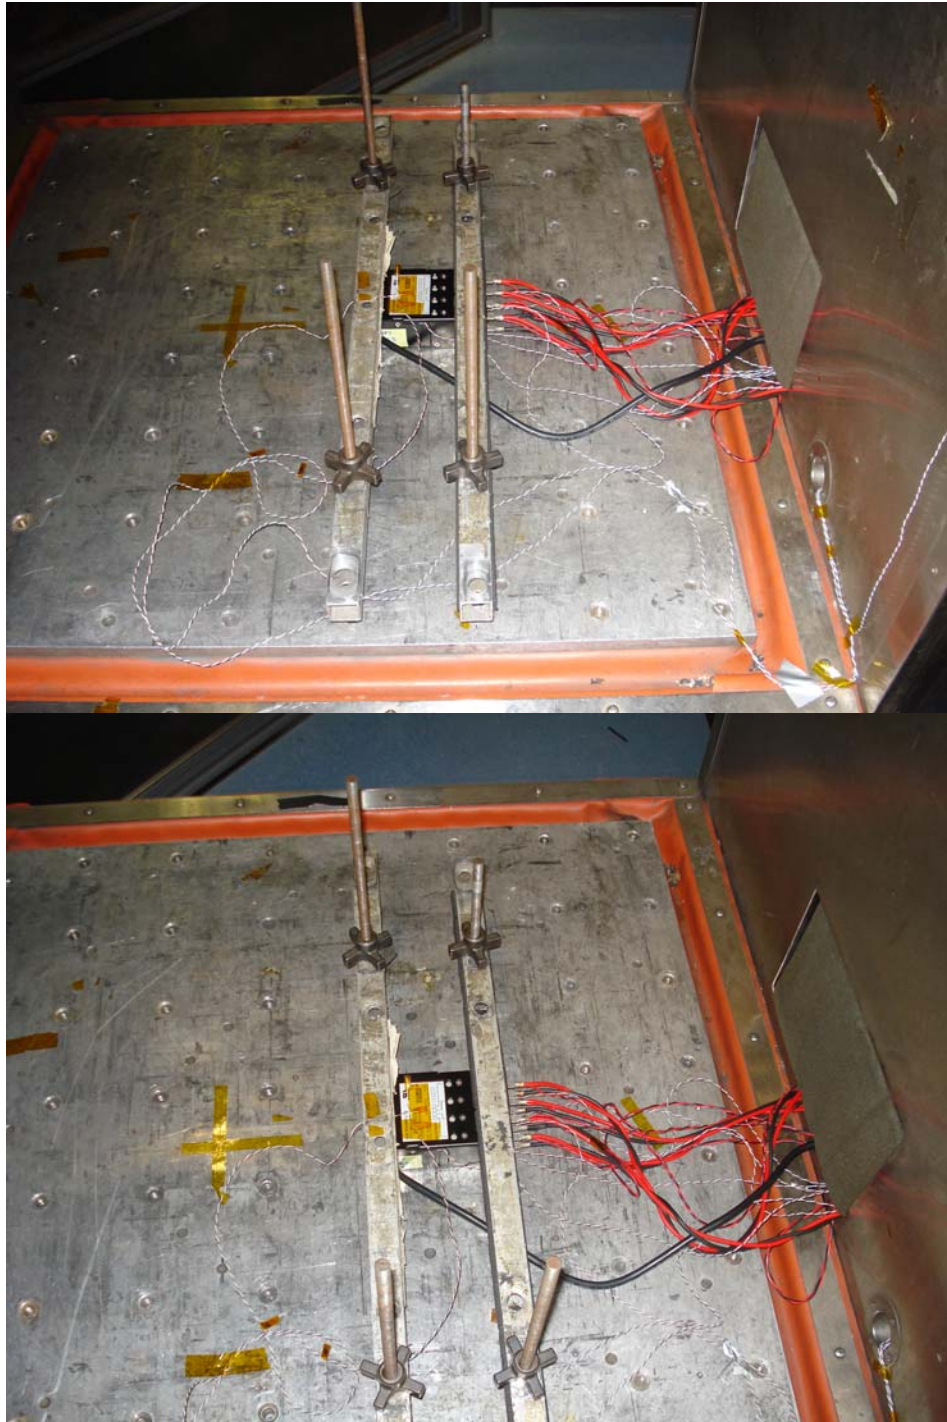
Figure 1 – Thermal and vibration Set-up

The product was tested one unit at a time. The product under test was secured using two bars of aluminium U-channel and all-thread to clamp the metal chassis to the vibration table. Air from the chamber plenum was directed onto the units. The fixture was designed to maximize both transmission of energy from the vibration table to the product and thermal transition rates, as well as to help maintain consistent temperatures on all the components inside the test units. Pictures illustrating the fixturing and arrangement of test units in the test chamber are presented in Appendix A.

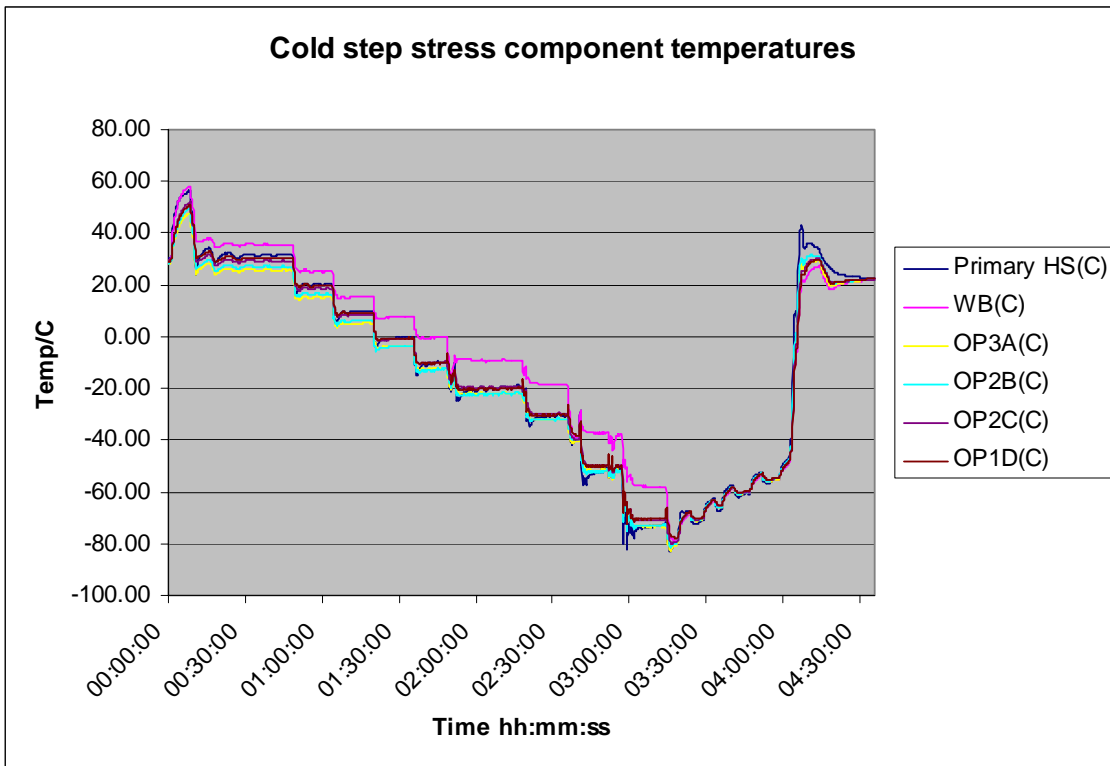
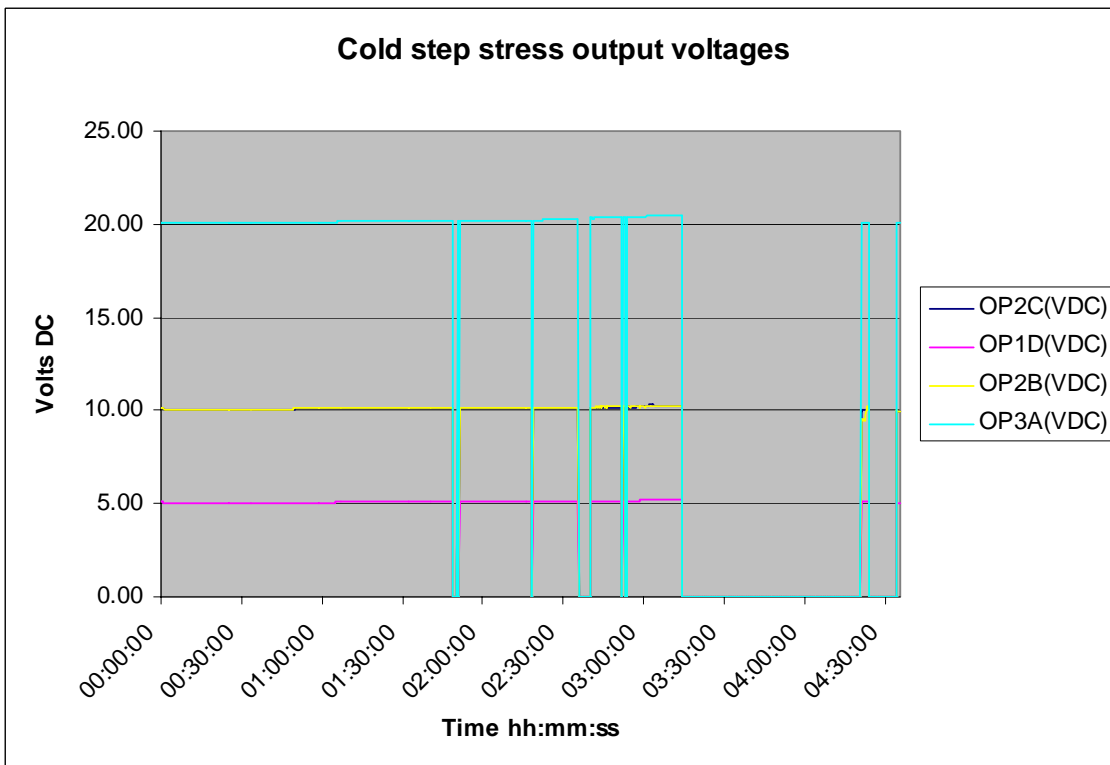
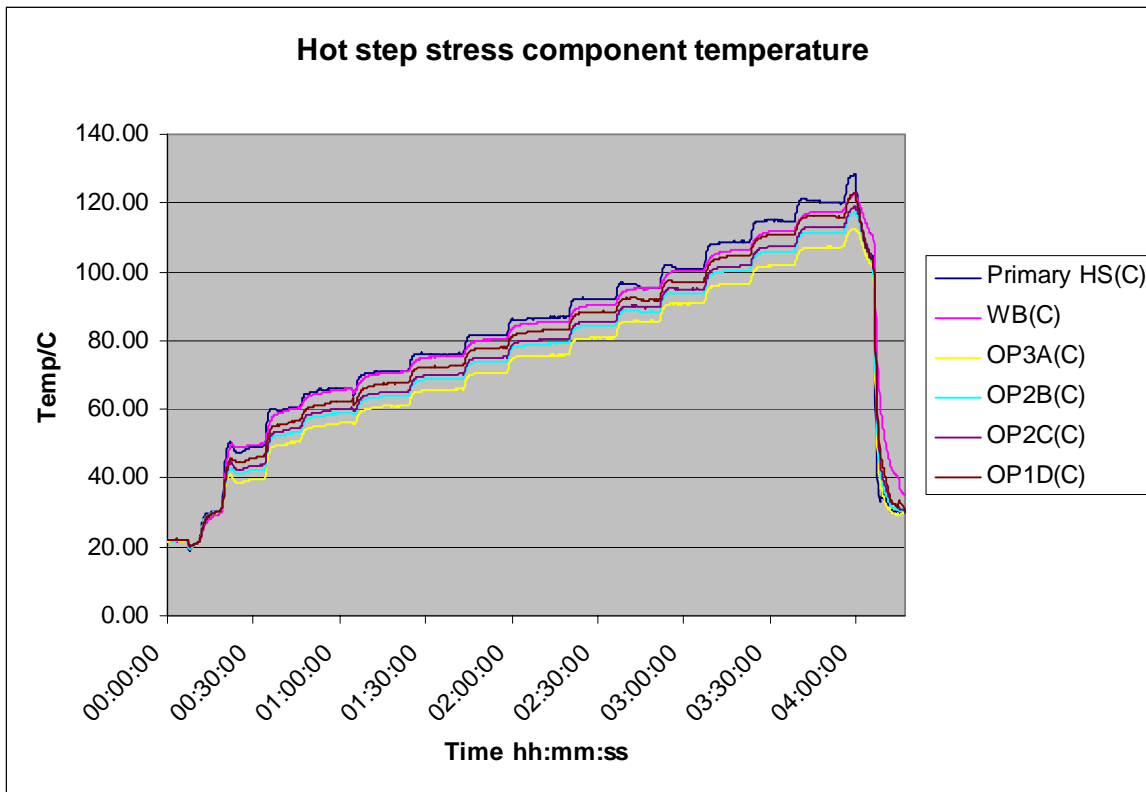
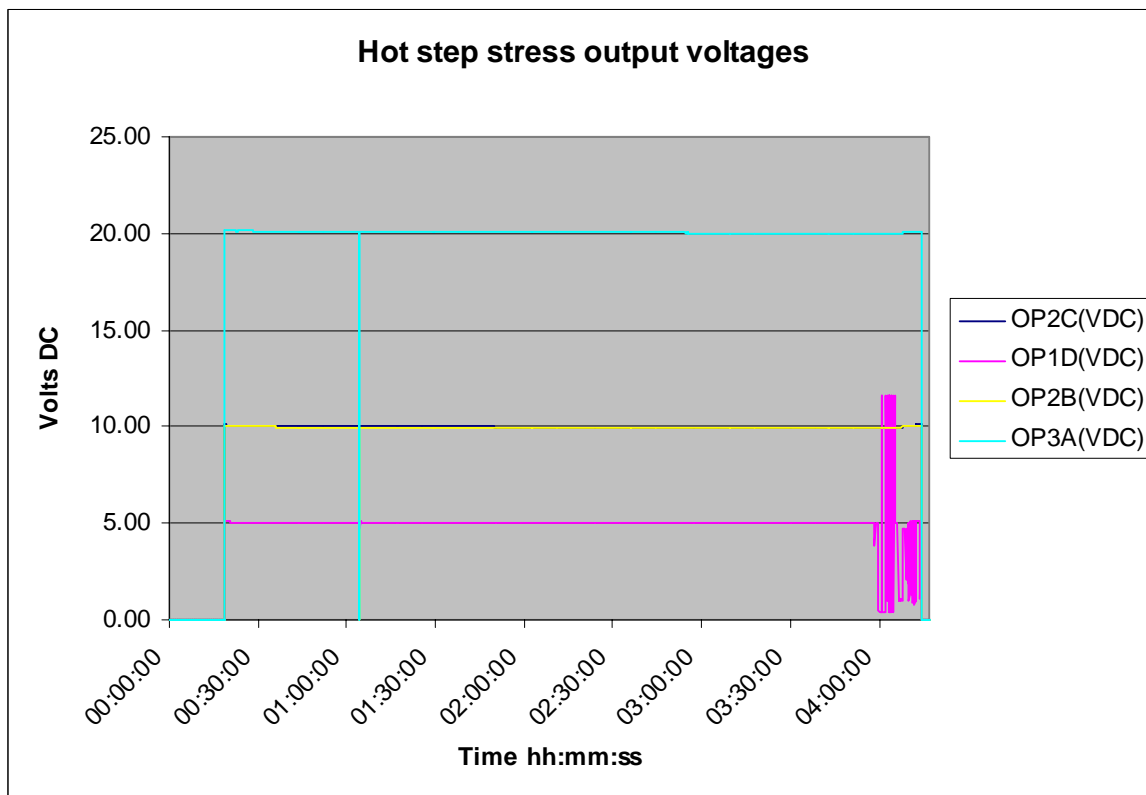
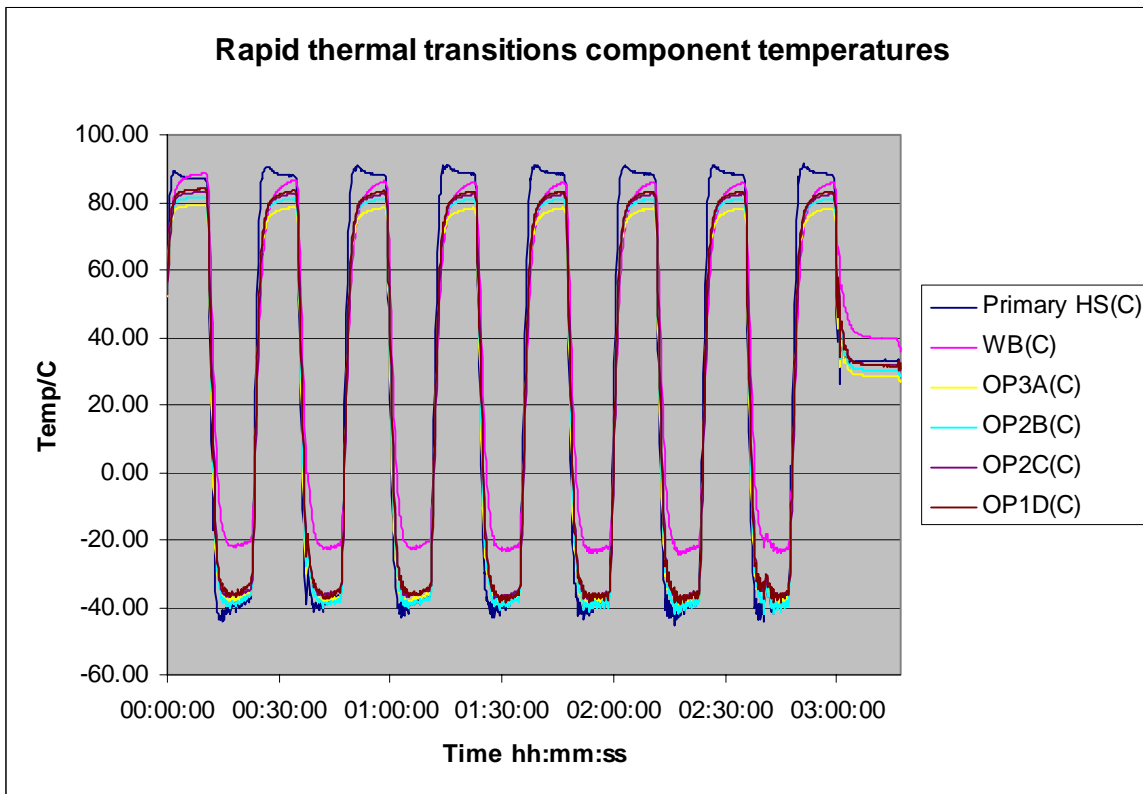
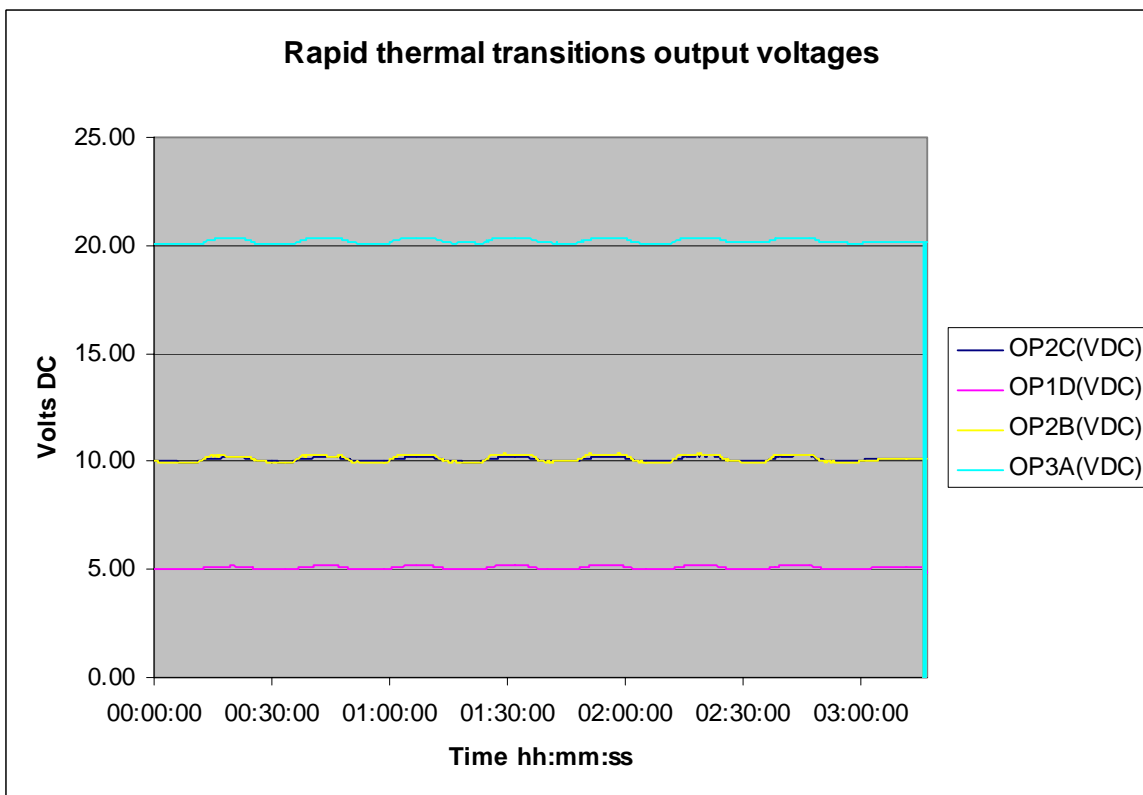
**Appendix B – Thermal and Vibration Graphs**

Thermocouples were attached to various points on the devices under test using kapton tape. These thermocouples remained in place throughout thermal step stress and rapid thermal transitions. The product thermal response at each thermocouple location was recorded at each level of thermal stress. See appendix B for thermal graphs.

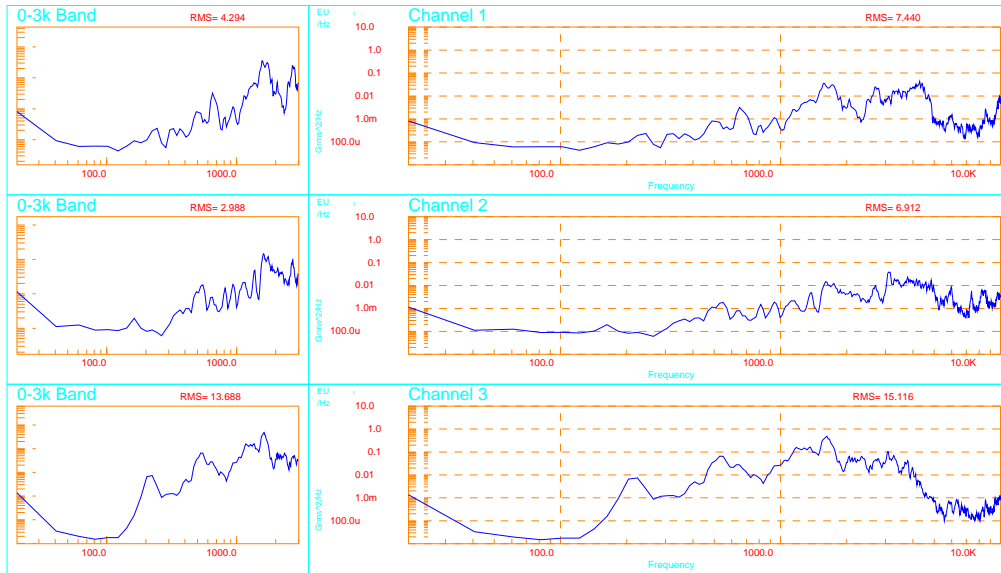
### 5 Grms

The device under test was clamped firmly to the vibration table to maximise energy transmission and subjected to vibration step stress beginning at a setpoint of 5 Grms with the vibration increasing in 5 Grms increments at 15 minute intervals. The results are summarized in Tables 9a and 9b.

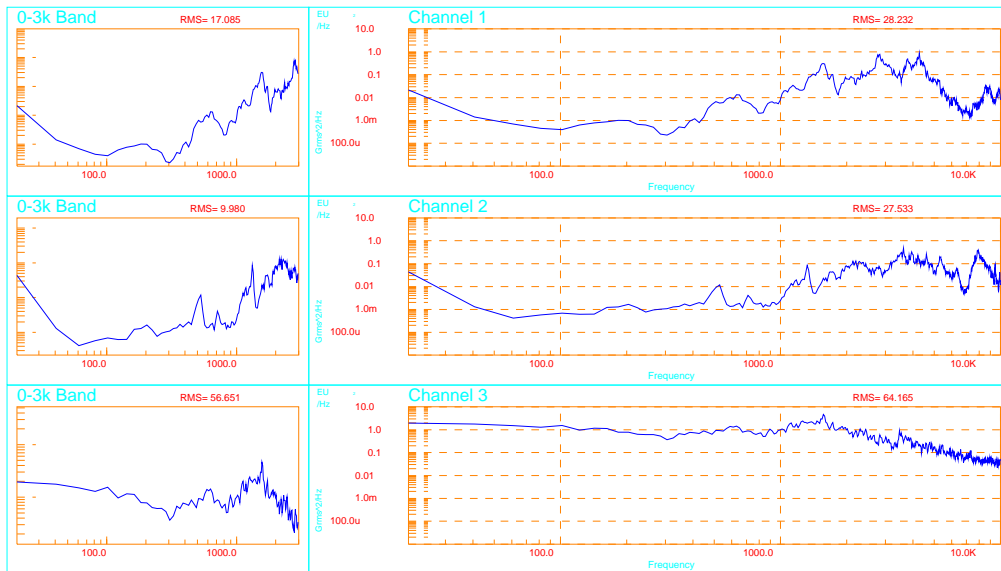
### 35 Grms

1. The system was functionally tested and during every dwell.
2. At the end of the dwell at 25G the 20V output module 3 in slot A shut down.
3. At 35G all outputs turned off and testing was stopped, two of these modules recovered when the vibration stopped but two remained inoperable. The problem was due to intermittent contact in the module connectors which caused excessive arcing and burned the connector.
4. Additional vibration testing and analysis with another unit showed that there was also an issue with the output modules contacting the power transformer core on the wiring board causing mechanical damage to the transformers. This occurred at vibration levels of 20G and above.
